EIFS Inspection Report

████████████████████
Virginia Beach, VA 23453

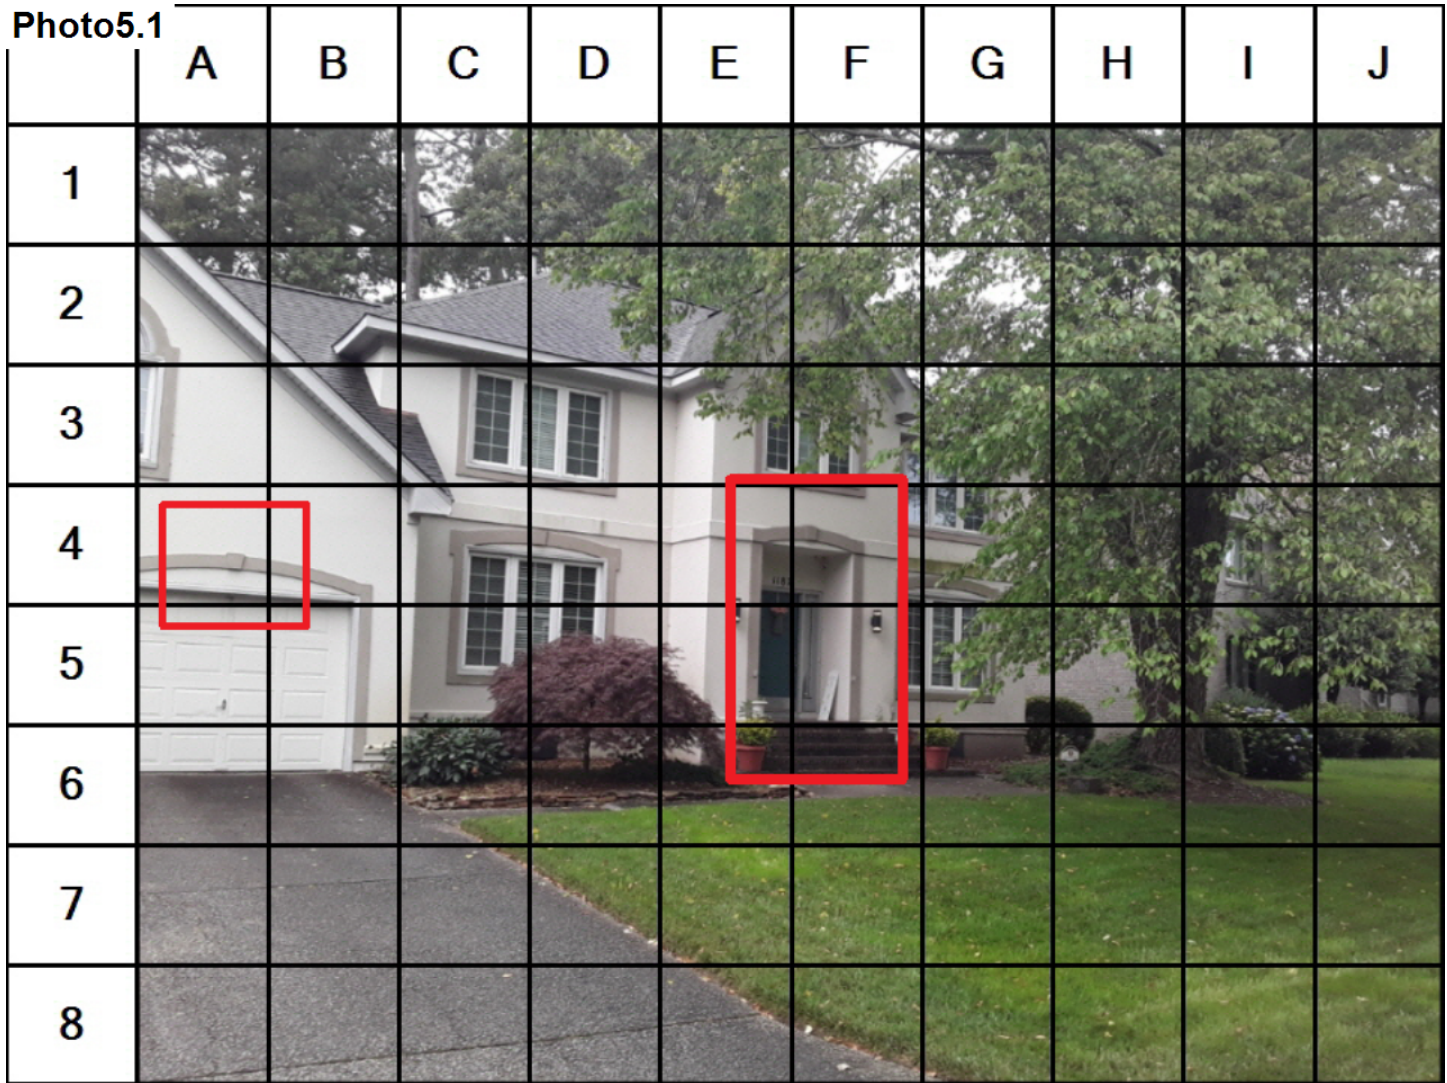
Photo5.1

Item	Item Description	Applies to Entire Bldg	Observations / Comment
	Cracks	Yes	Exposed cracks need to be repaired
5E-5F, 4E-4F	Damage	Yes	Damaged stucco needs to be repaired.
	Windows	No	Most windows are sealed but some need to be sealed at the frames and construction (tracks, joints) need to be caulked.
Thru-out	Finishes	Yes	The finish coat needs cleaning and repainting

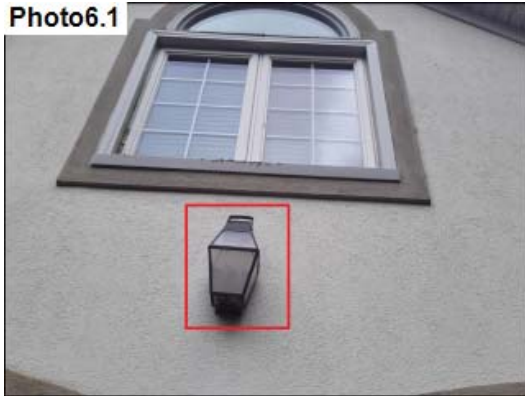
Photo6.1

Compression Crack
Light Fixture needs to be sealed

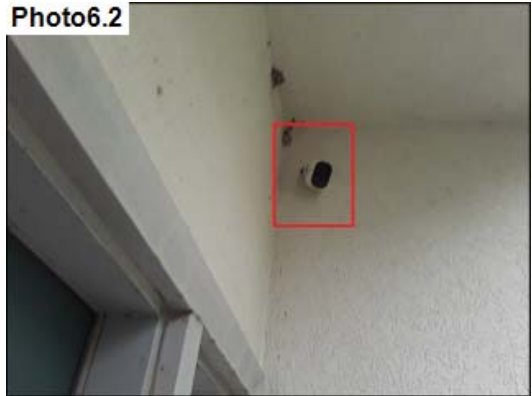
Photo6.2

Hole behind the camera needs to be repaired.

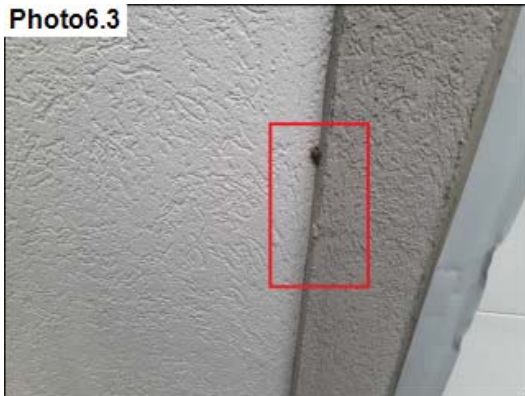
Photo6.3

Impact damage and exposed mesh

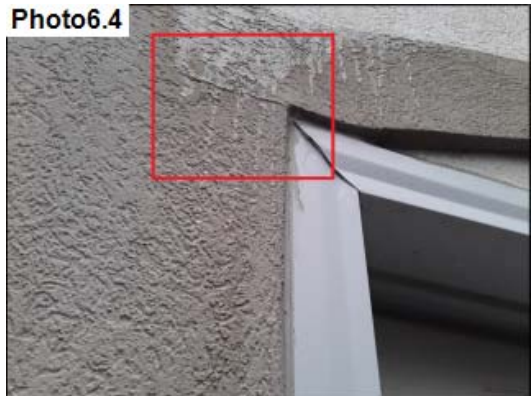
Photo6.4

Compression Crack

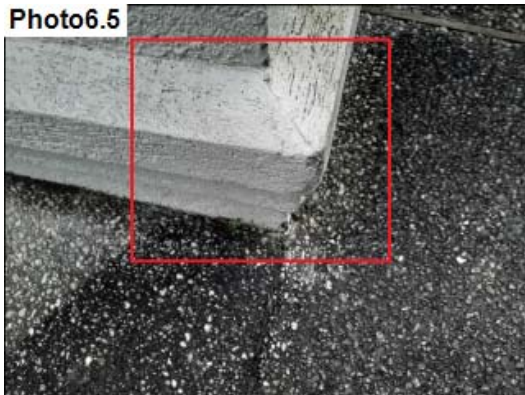
Photo6.5

Impact damage at front corner of
water table band

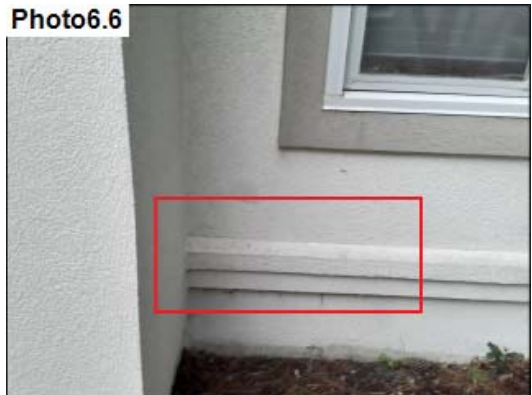
Photo6.6

Impact damage at water-table band

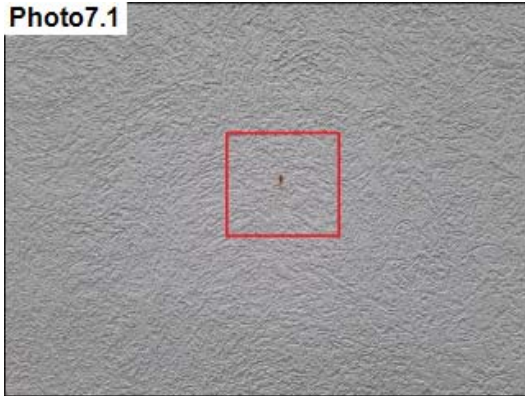
Photo7.1

Aggregate rust stains thru-out

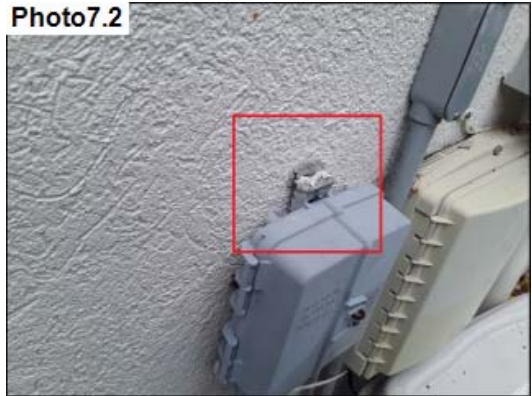
Photo7.2

Needs sealant

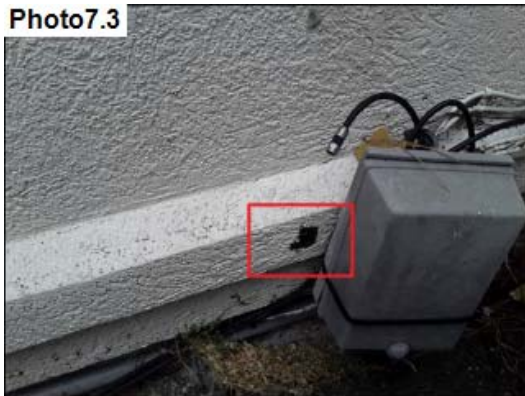
Photo7.3

Hole in the band

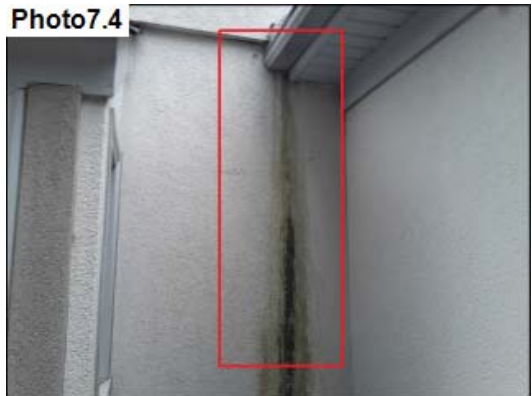
Photo7.4

Mildew & stains from roof

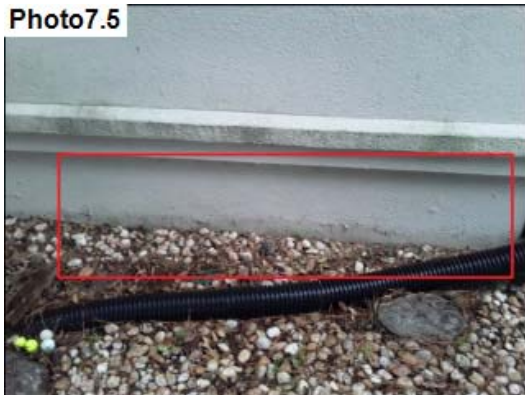
Photo7.5

Foundation paint peeling off

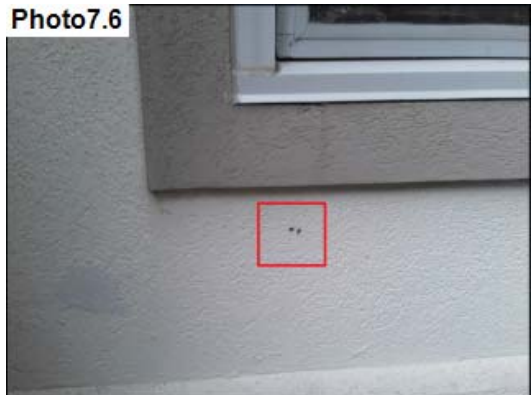
Photo7.6

Previous inspection holes not sealed

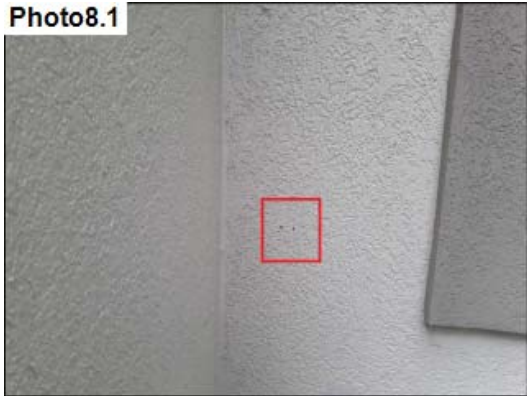
Photo8.1

Probe holes not sealed

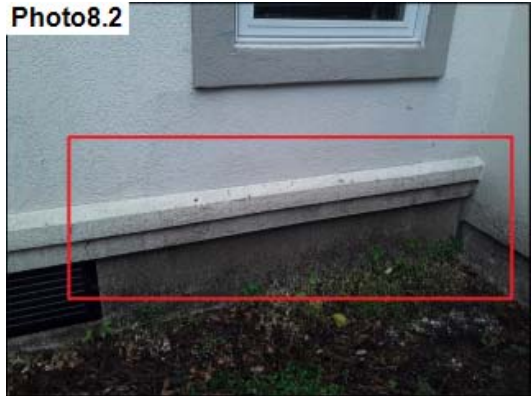
Photo8.2

Impact damage thru-out

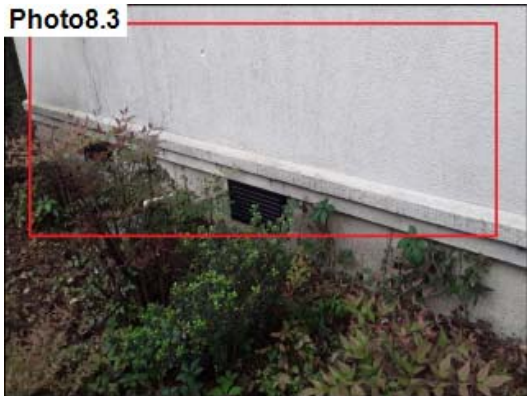
Photo8.3

Impact damage and vegetation on lamina

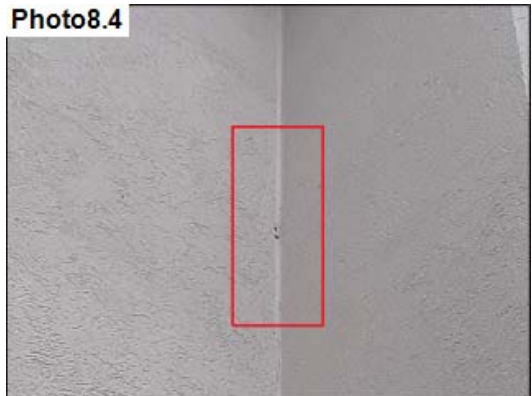
Photo8.4

Sealant failure at chimney

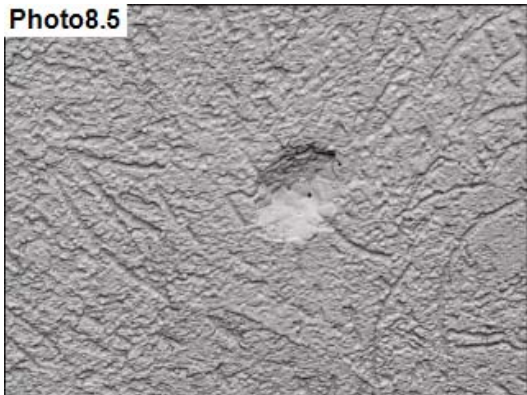
Photo8.5

Typical impact damage thru-out

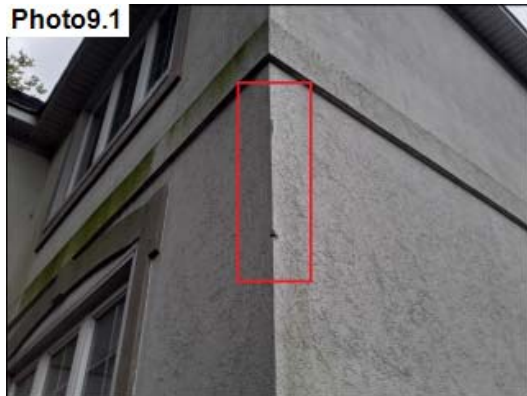
Impact damage at front right corner

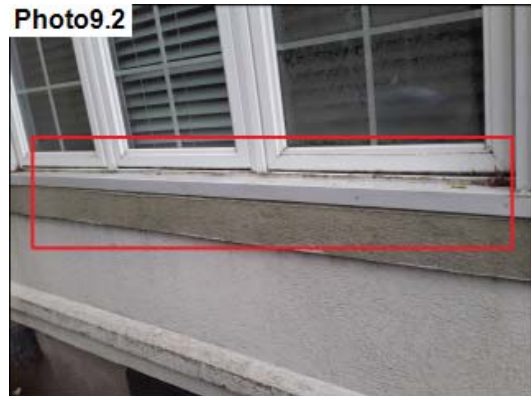
Some windows need resealing

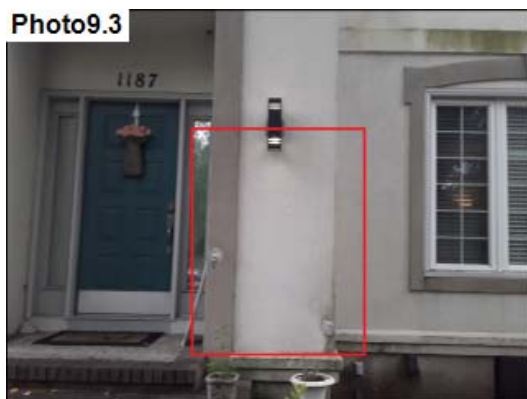
Repair needed where railings were removed

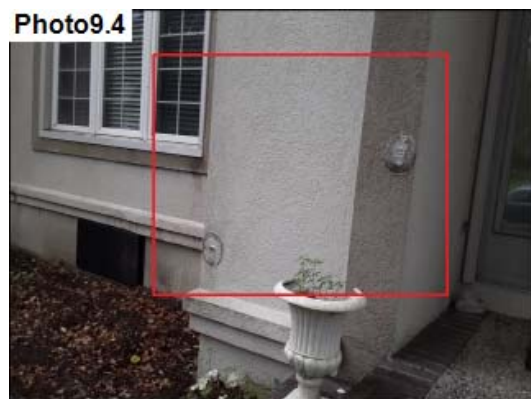
Repair needed where railings were removed

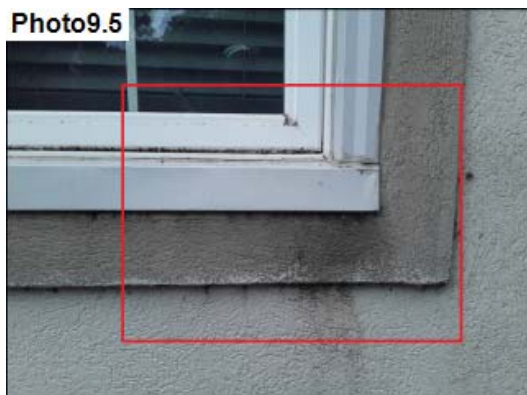
Sealant needed at most windows

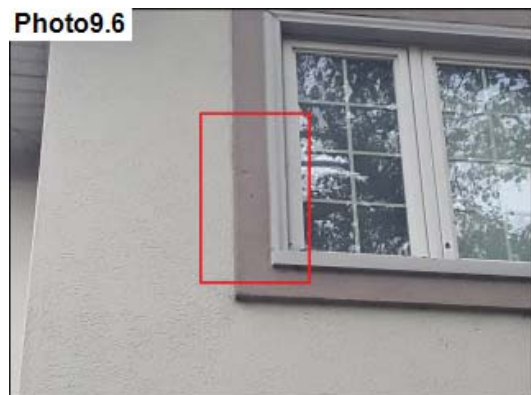
Impact damage and compression crack
