EIFS Inspection Report

████████████████████
Virginia Beach, VA 23453

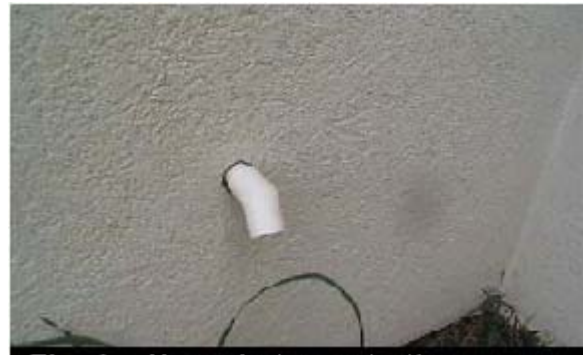
Fig. 1 Unsealed penetration

All penetrations must be sealed with a compatible sealant as recommended by the EIFS/Stucco system manufacturer and required by Model Codes. Damaged areas of stucco must be properly repaired to prevent water intrusion.

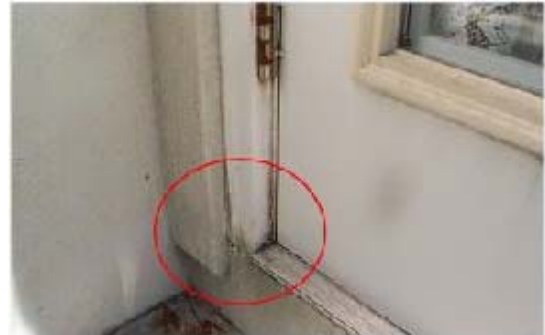
Fig. 1: Damage caused by No sealants

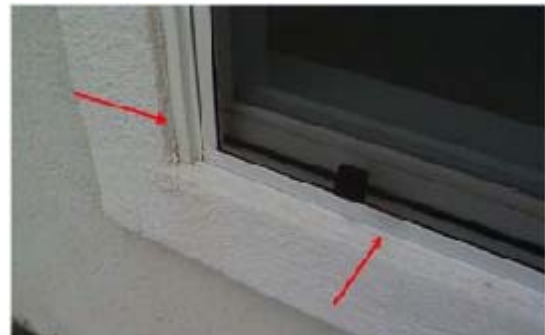
Fig. 2: Example of unsealed window perimeter

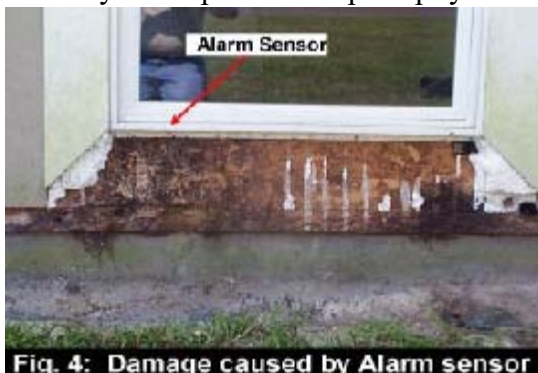
Fig. 4: Damage caused by Alarm sensor

Punctured window tracks or frames from security system installation. This may also void your window warranty. Sealing these penetrations will many times correct the leakage.

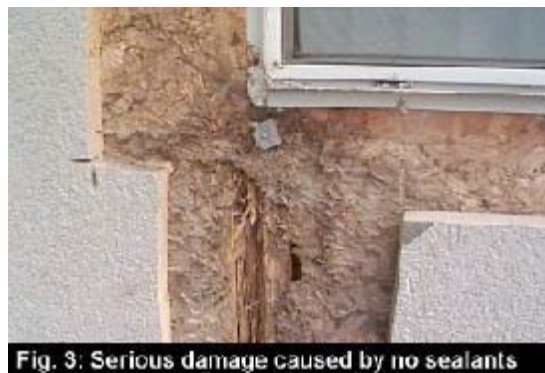
Fig. 3: Serious damage caused by no sealants

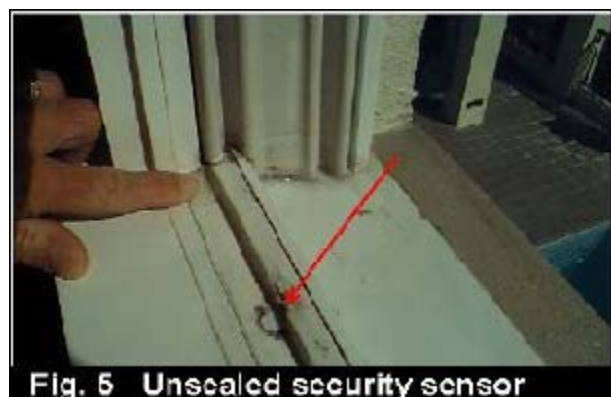
Fig. 5 Unsealed security sensor

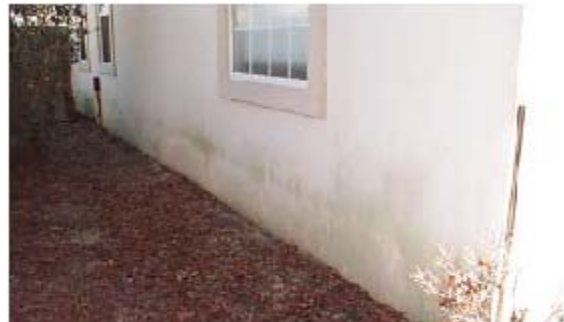
1) To prevent wicking, a process in which standing water is absorbed by the EPS foam board, which leads to mold and mildew behind EIFS. Figure 1 shows an example of a home where the stucco system was not backwrapped and extended below grade. Water wicked up behind the EIFS/Stucco causing mold, mildew and decay of the underlying sheathing. Wicking can also occur when EIFS/Stucco is terminated at grade level as seen in Figure 4.

Fig. 1 Moisture caused by the wicking process

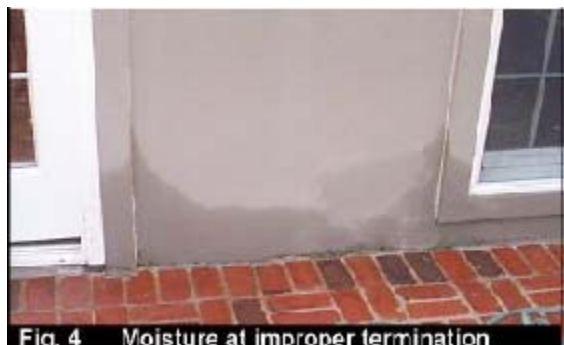
Fig. 4 Moisture at improper termination

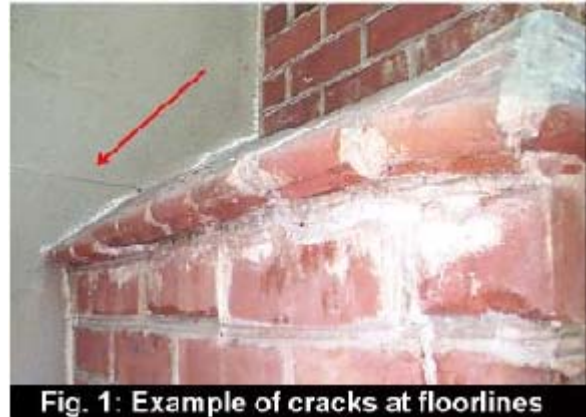
Fig. 1: Example of cracks at floorlines

It does not take a very big crack to allow water intrusion. In fact, a crack as small as 1/16" of an inch wide can permit water to enter behind the EIFS/Stucco especially with a EIFS/Stucco system that has no moisture barrier. All cracks 1/16" wide or larger and all damaged areas of EIFS/Stucco should be properly repaired as per manufacturers guidelines. Many times the patched areas will still be slightly noticeable even with a good repair application. Extreme cracking will sometimes require the reapplication of EIFS base, mesh, and finish to prevent more cracking and provide a consistent appearance. Cracking is common in hard coat stucco systems, therefore expansion joints are called for every 144 sf, as well as between floorlines and extending vertically from window and door corners to help control cracking. One reason EIFS is so popular, is that these expansion joints, which many feel are unsightly, are not usually necessary with EIFS. The exception to this is that they are needed between floorlines to compensate for the cross-grain shrinkage of wood. As seen in Figure 1, the lack of an expansion joint between floorlines will result in a compression crack in this area. Again, consult with manufacturer for specific requirements of expansion joints.

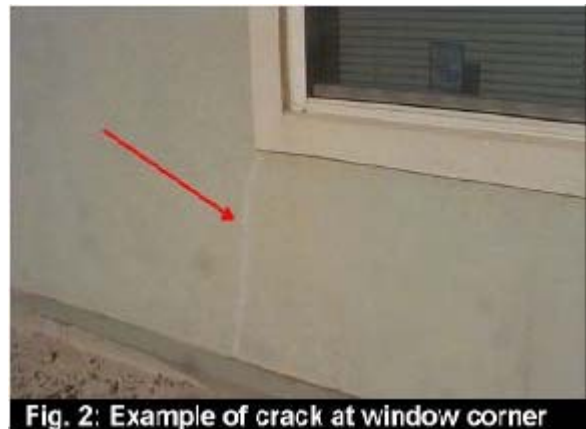
The most common areas that experience cracking in EIFS are at the corners of windows or roof terminations as seen in Figures 2 and 3. To prevent cracking in this area, most manufacturer and EIMA details specify that an additional layer of reinforcement mesh be applied diagonally at the corners of all windows, doors and other openings. This is called "butterfly" mesh.

Fig. 2: Example of crack at window corner

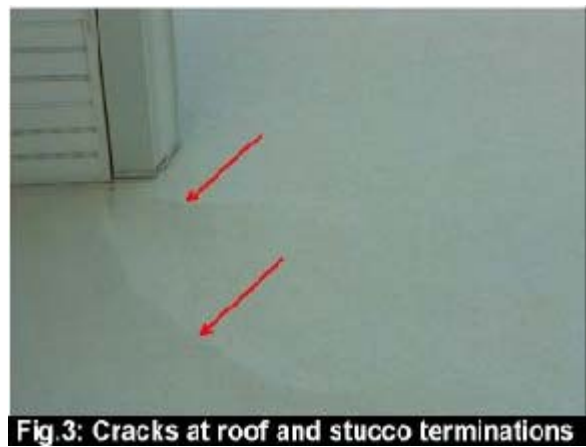
Fig. 3: Cracks at roof and stucco terminations

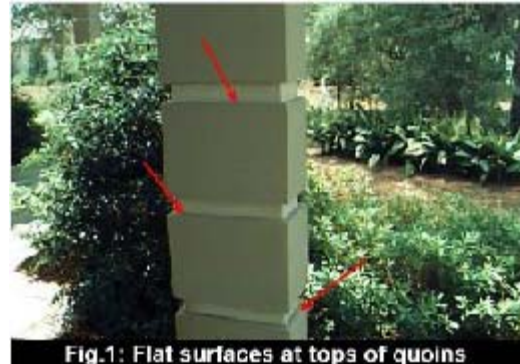
Flat stucco surfaces, whether conventional hard coat stucco or EIFS, collect and hold water in its rough texture, softening the finish coat, damaging the system and promoting leaks, mildew and discoloration. A good EIFS design will call for bands, quoins, and other accents to have a slope to prevent water accumulation.

Fig. 1: Flat surfaces at tops of quoins

The easiest corrective measure would be to coat all flat surfaces with an elastomeric waterproofing coating tinted to match the existing EIFS/Stucco color as closely as possible. Large flat areas, such as a parapet wall, can be capped with metal and sealed.

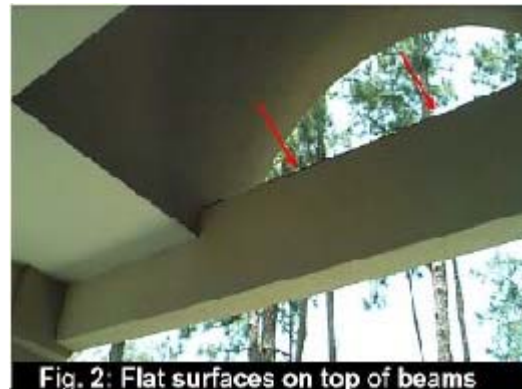
Fig. 2: Flat surfaces on top of beams

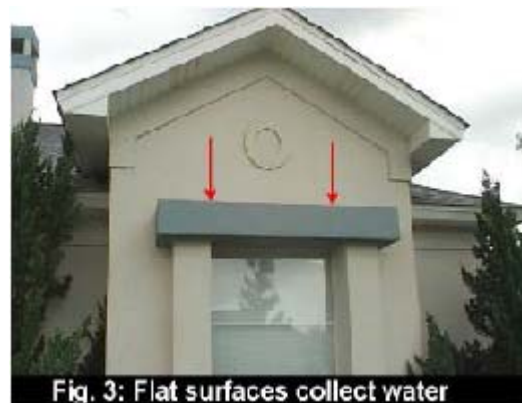
Fig. 3: Flat surfaces collect water

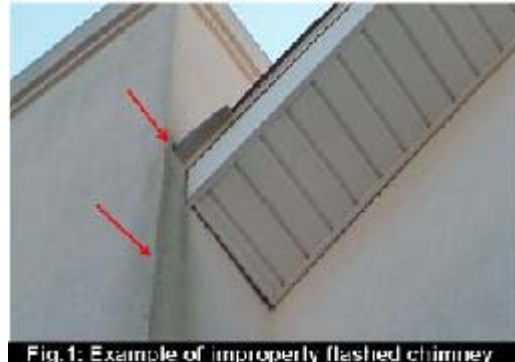
Fig.1: Example of improperly flashed chimney

Figure 1 shows a chimney that was not properly flashed (sidewall and kickout flashing see section 3.4) which resulted in wood rot and termite infestation. Figure 2 shows a chimney coping that was not sealed to the EIFS/Stucco which has now separated and will allow water into the chimney chase.

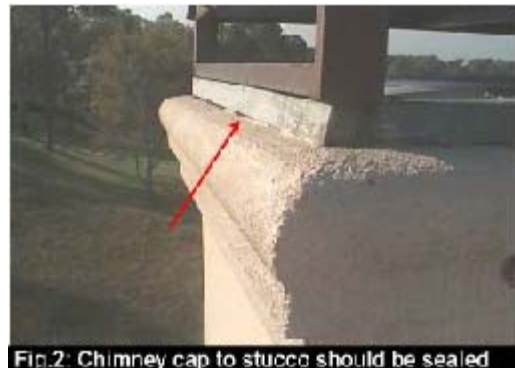
Fig.2: Chimney cap to stucco should be sealed

A properly designed chimney cap (coping) will shed water away from the stucco to metal joint (Figure 2) and help prevent leaks in this area. The flue should be properly sealed to the "storm flashing" and the chimney cap (coping) sealed to the EIFS/Stucco

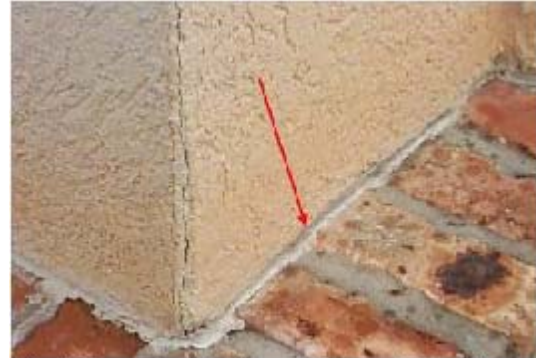
Different materials expand and contract at different rates. This expansion and contraction causes a crack or gap to form where the two materials join.

Fig.1: Stucco to brick transition needs sealing

If left unsealed, or if sealed improperly, this area will allow water to enter the wall cavity. Examples of this would include EIFS/Stucco to wood trim, stucco to brick (Figure 1), stucco to stone (see Figure 2), stucco to concrete, etc. All areas such as these should be sealed with quality sealants and appropriate bond breakers.

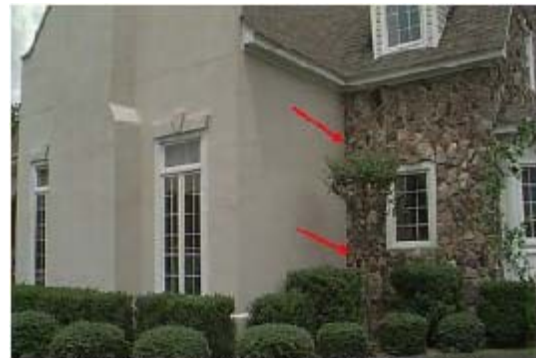
Fig.2: Stucco to stone needs to be sealed
