# Stop Woodpecker Holes. For Good.

Ultra-Guard EIFS™ is a woodpecker-resistant insulated stucco system. It looks like your existing EIFS, but birds can't drill through it.

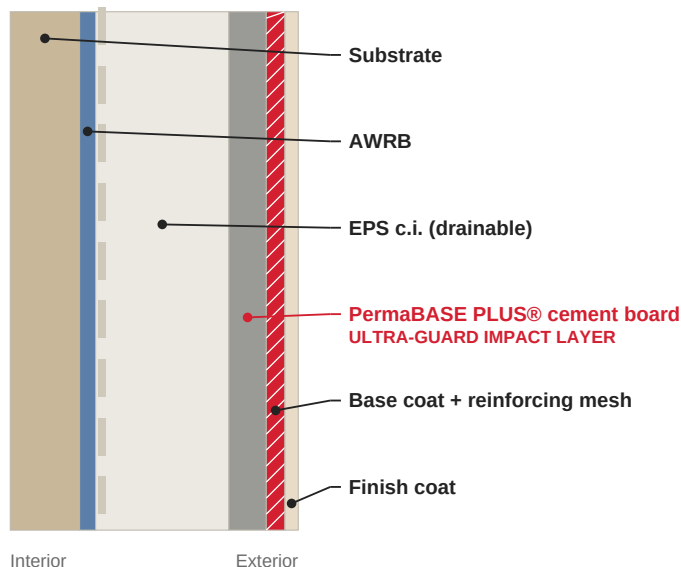
TYPICAL ULTRA-GUARD WALL SECTION

Ultra-Guard adds a rigid **cement board impact layer** over the insulation, under the reinforced base coat and finish. A peck hits a hard surface instead of foam. You keep the insulation, drainage and stucco look.

Standard EIFS is a thin finish over soft foam. To a woodpecker it sounds hollow and drills easily, so birds dig in after insects or to build nests. Every hole lets water in behind the wall, and patching just rebuilds the same soft surface they hit last year.
